Re: Responses to EPA Comments and Submission of *Restoration of Reach 1, of Dicks Creek, Monroe Ditch, and Outfall 002, Operation and Maintenance Plan, AK Steel Corporation, Middletown, Ohio, Revision 2, April 2014*

Responses to EPA April 1, 2014 Comments
Dicks Creek Reach 1 and Monroe Ditch – Recommended Changes to O&M Plan Outline
(Revised April 2014)
O&M Plan Revision 2, April 2014

Dicks Creek and Monroe Ditch – Recommended Changes to O&M Plan

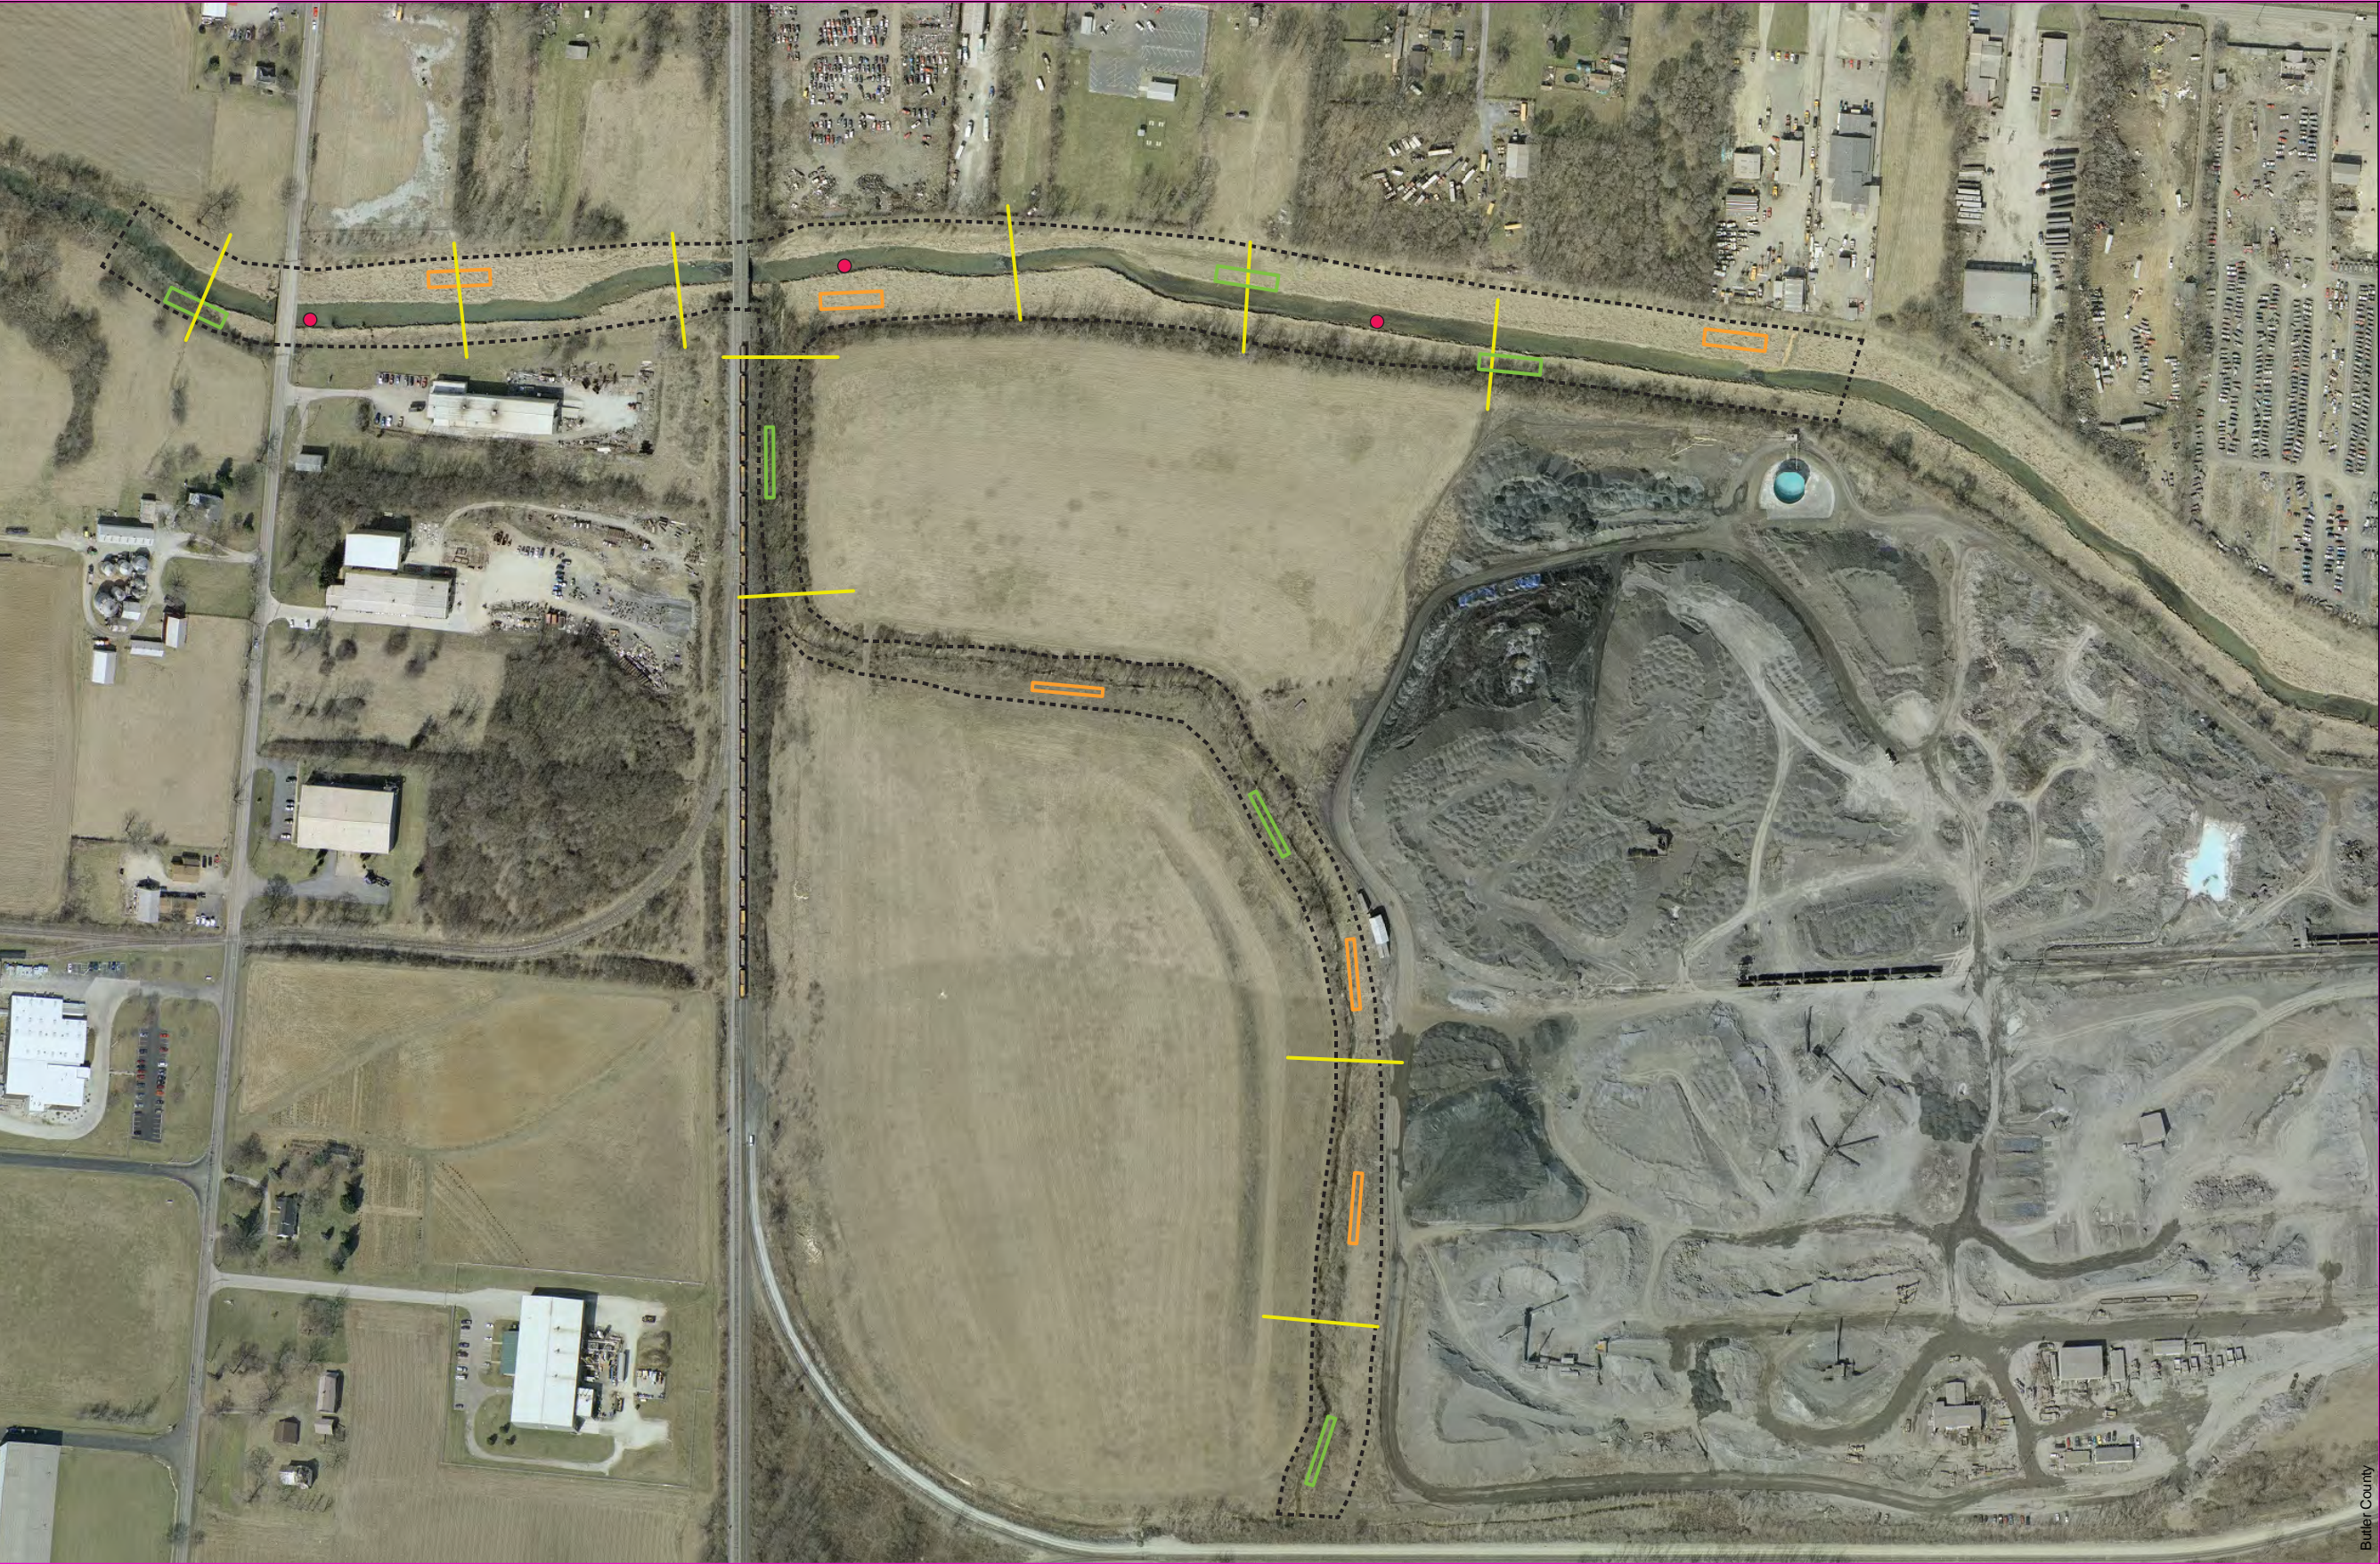
FIGURES

- LEGEND
- Proposed QHEI Zones
 - QHEI Locations 1987-2000
 - FQAI Forest/Meadow Areas
 - FQAI Forest Areas
 - Restoration Limits

- A visual assessment of physical habitat conditions will be used to determine the Qualitative Habitat Evaluation Index (QHEI) for each fish sampling zone (Section 3.4.2).
